Fiddler's Creek Community Development District #1 OFFICE OF THE DISTRICT MANAGER

Fiddler's Creek Monument Signs and Perimeter Fence Pictures

September 27, 2017 Hurricane Irma Damage Assessment

Fiddler's Creek Community Street Signs Irma Storm Damage Assessment

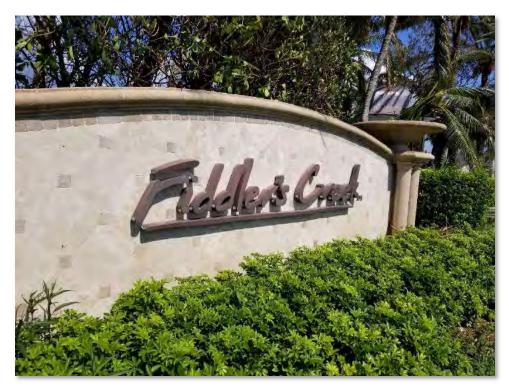
North Monument Sign (Typical for both signs)

No Damage to the lettering, tiling, or front façade observed.

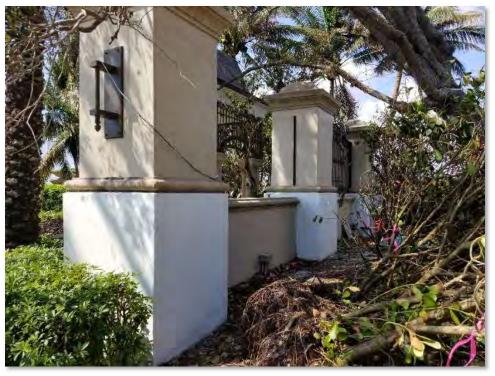
North Monument Sign Light Fixture on End missing and damaged Metal Railing in between columns sheared from column and wall anchors

Recommendations: Replace top accent pieces on pillars. Replace planter bowel at south end of low wall. Schedule inspection of pump equipment. Possible heaving and wash-out of backfill at bulkheads; schedule detailed structural inspection. Replace broken lighting fixtures and metal railing.

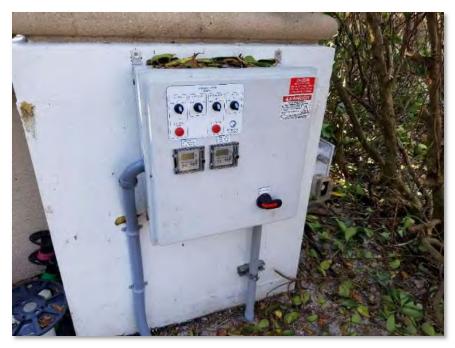
Fountain and Lighting Control (Behind North Sign and turned off) No external damage observed.

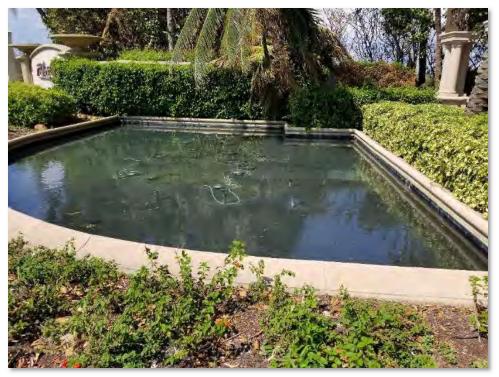
North FountainNo damage to concrete wall or cap observed.

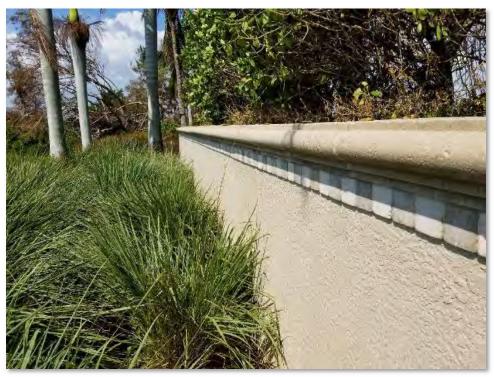
North WallNo damage to concrete low wall or planter bowel observed.

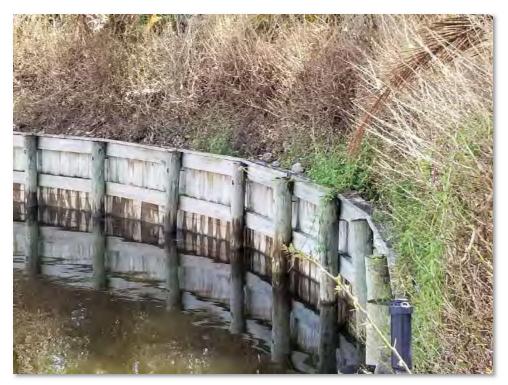
North Bulkhead No damage to piles, cap, or horizontal supports observed.

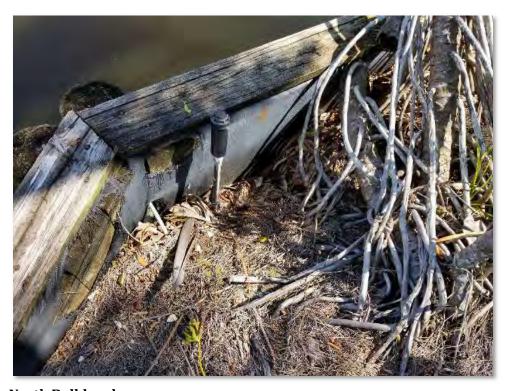
North Bulkhead Two (2) areas where backfill has washed-out and exposed tie-backs

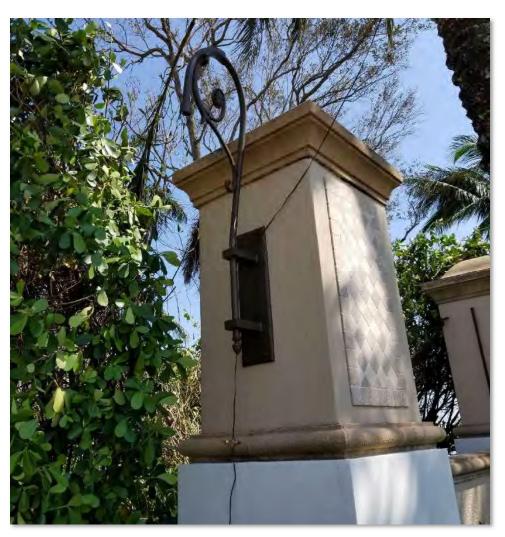
South Monument Sign Left End Lighting Fixture Missing

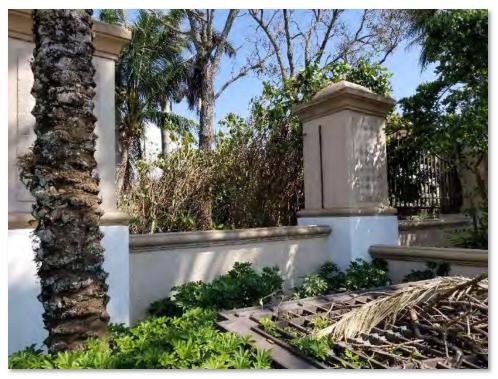
South Monument SignMetal railing in between columns sheared away from column and wall anchors

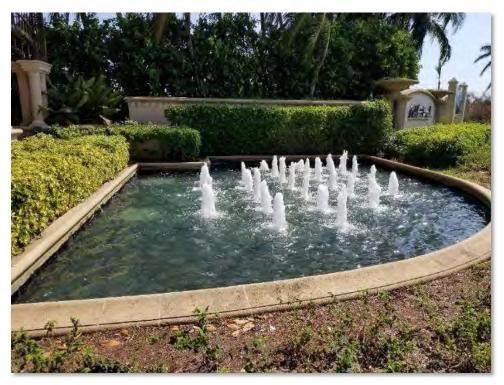
South Fountain

Fountain running at time of observation. Electrical panel door locked at time of observation. No damage to the fountain wall or cap observed.

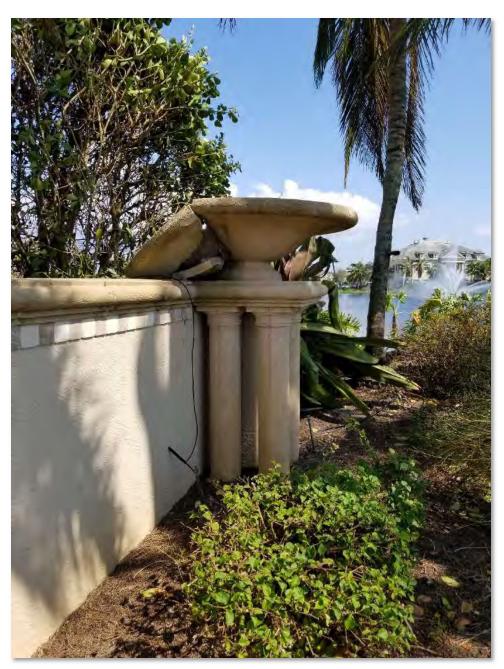
South Wall End planter bowel broken.

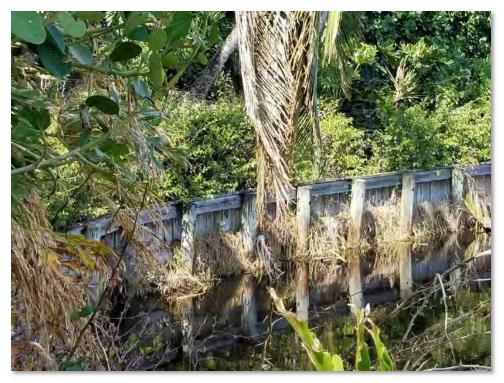
South Bulkhead Some piles are misaligned and leaning towards the lake.

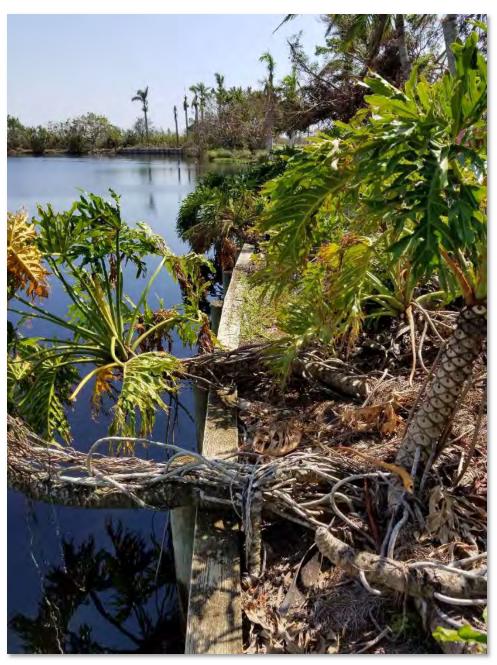
South Bulkhead (behind end of southern wall) Heaving towards lake and some wash-out of backfill observed.

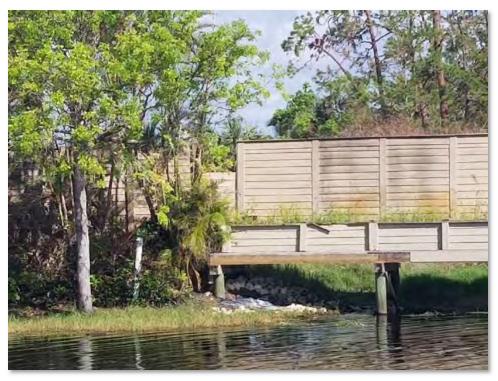
Aviamar (Damage to horizontal panels, planter box, and exterior siding on cap board.)

Recommendations: Repair and replace masonry fence sections. Repair and replace chain link sections. Repair north access swing gate. Estimated Cost: \$115,200

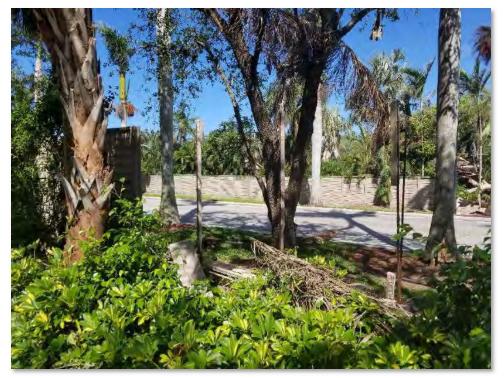
Championship Drive (Typical Damage)

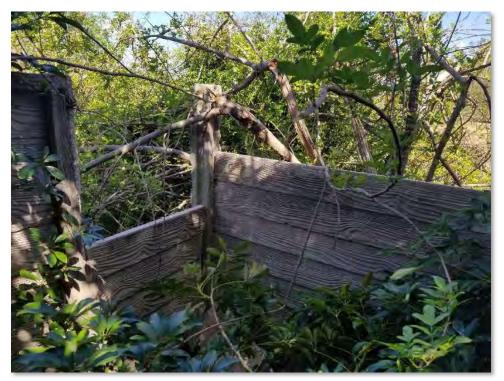
Veneta (Northwest Corner) (Typical Damage)

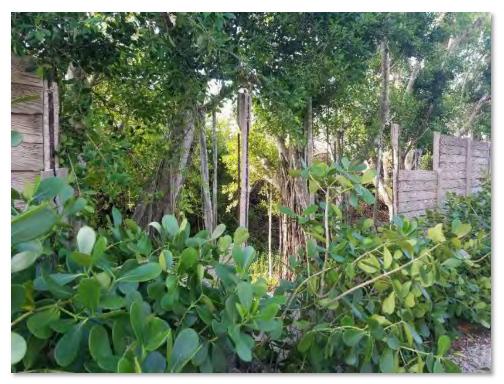
Mulberry Lane (Typical Damage)

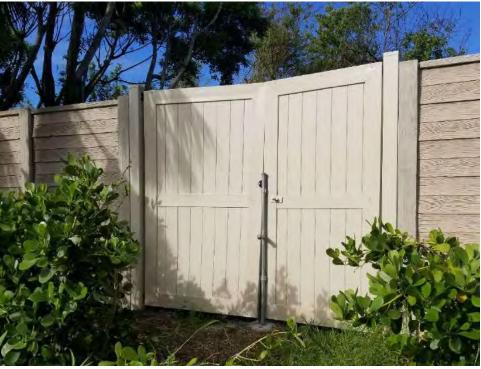
Mulberry Lane (North Access Gate Damage)

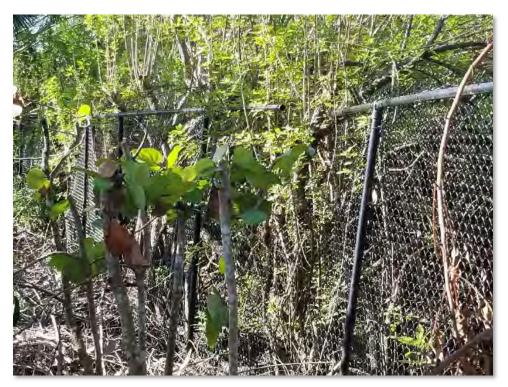
Mulberry Lane (Typical Chain Link Damage)

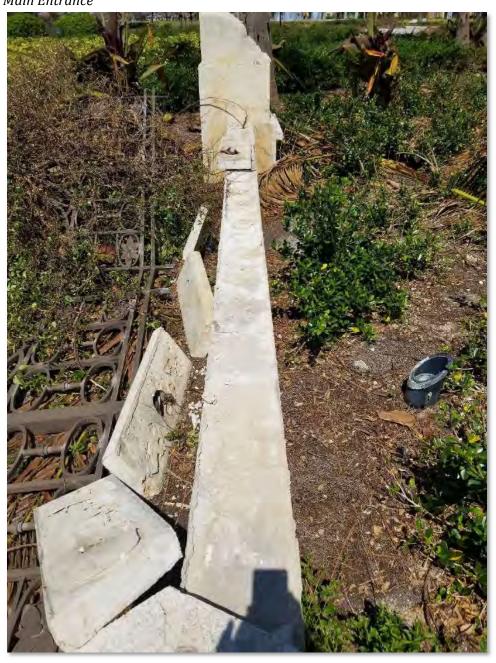
Damage to Metal Railing and Concrete Cap

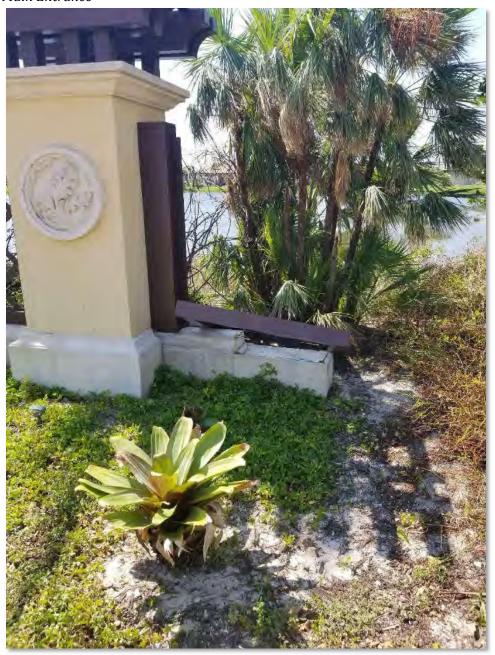
Damaged Metal Railing and Concrete Cap West Sign

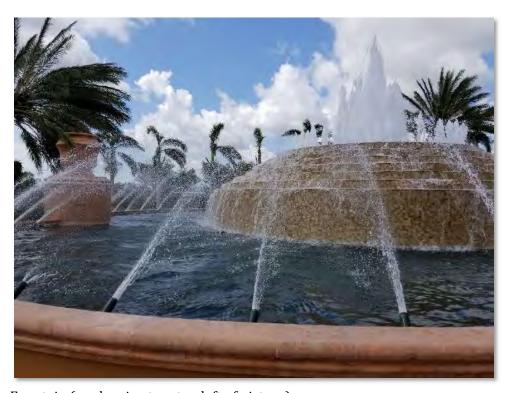
Fountain (see leaning tree top left of picture)

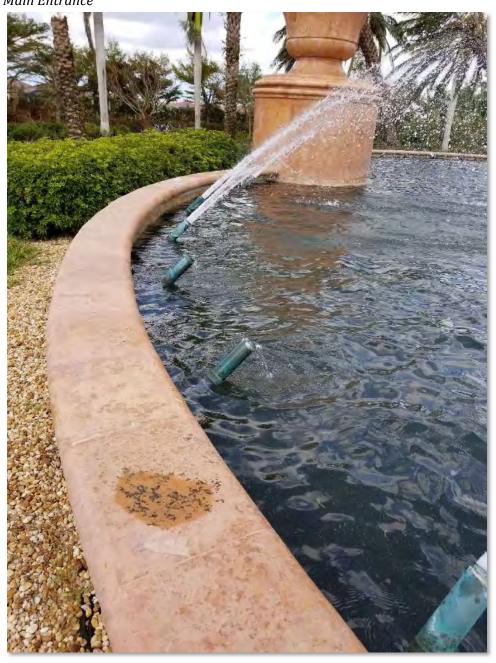
Fountain Elements not working

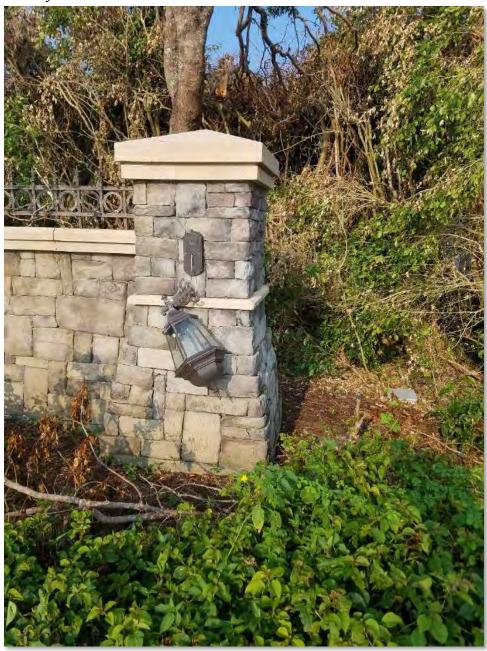
Damaged Light Fixture Right-Hand Side

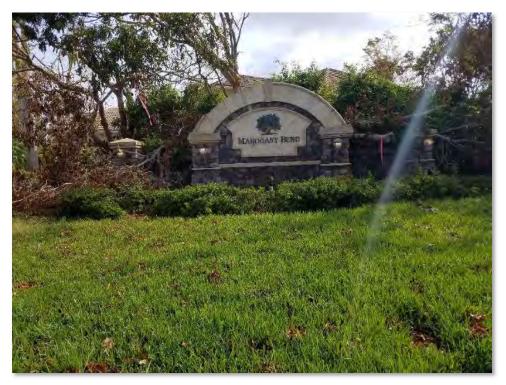
South Monument Sign (Damage to cap at top)

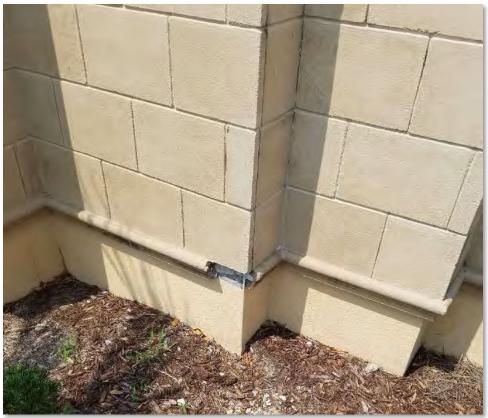
"Cranberry Crossing" Club Center Entrance (Bottom Right-Hand Side Façade Damage)

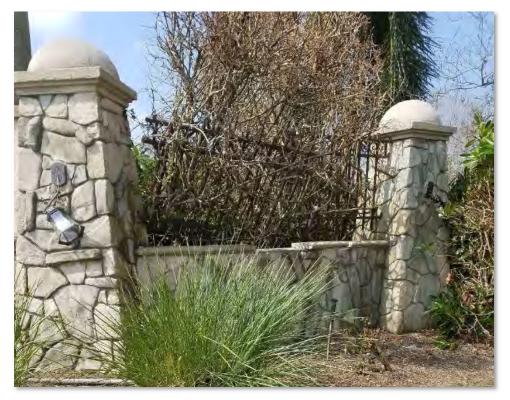
South Monument Sign (Right-Hand Railing and Cap Damage)

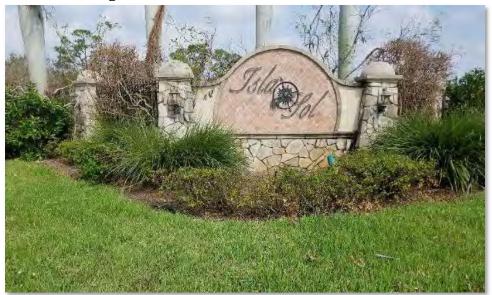
North Monument Sign (Left-Hand Railing and Cap Damage)

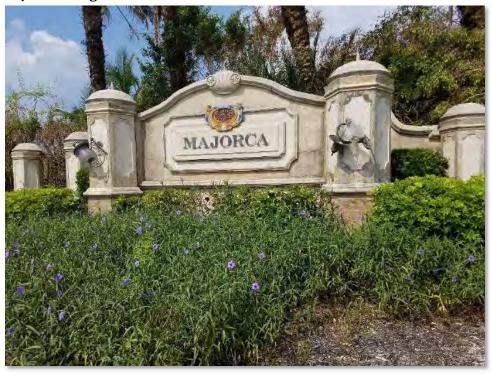
South Monument Sign (Light Fixture Damage)

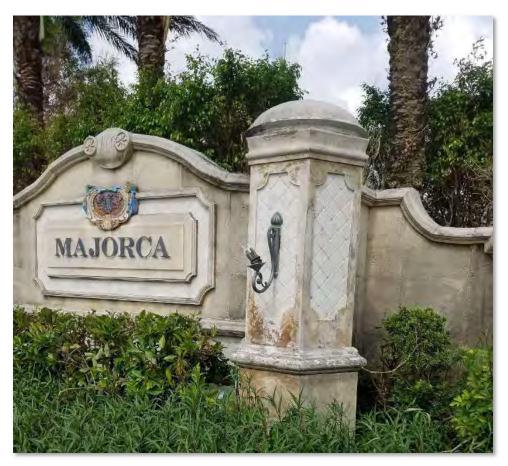
North Monument Sign (Light Fixture Damage)

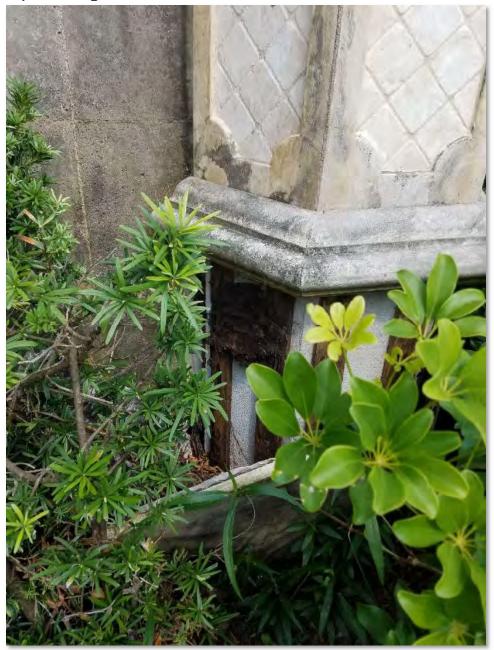
North Monument Sign (Bottom Left Façade Damage)

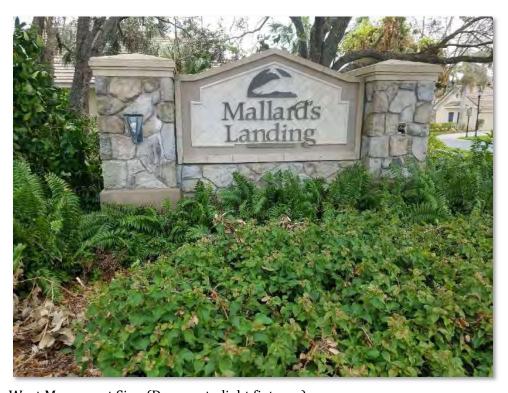
West Monument Sign (Damage to light fixtures)

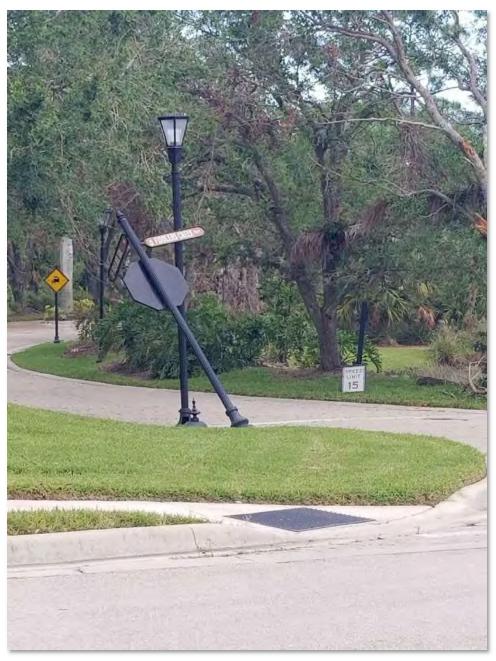
Directional and information street signs were assessed throughout the community. Damage varied from bent signs and poles to street signs only slightly leaning. Many stop signs have temporary construction grade signs in place in the intern until decorative poles and signage can be replaced. The spreadsheet is an inventory of the observed damaged signs with estimated cost.

Typical Bent Decorative Street Sign (Combination Stop Sign and Street Name) Typical Broken Decorative Sign (speed limit sign in background)

Recommendations: Replace and/or repair street signage (see spreadsheet for details) Estimated Cost: \$11,825

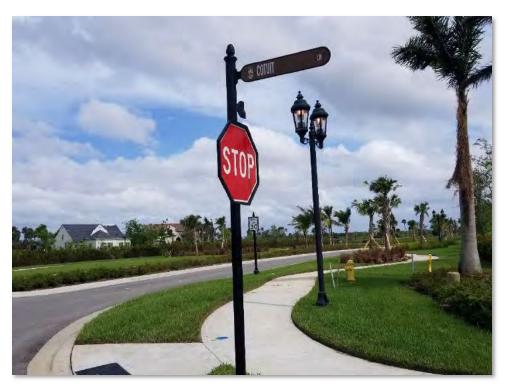
Typical Broken Decorative Street Sign

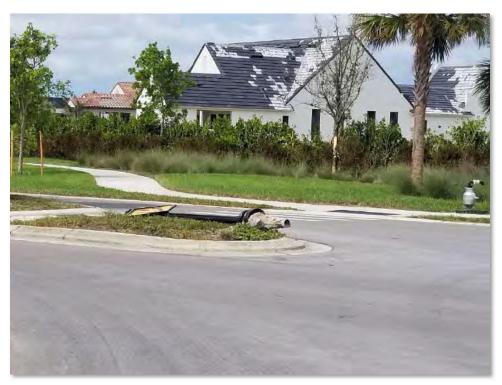
Typical Fallen Decorative Street Sign
