Fiddler's Creek Community Development District #1 OFFICE OF THE DISTRICT MANAGER

Fiddler's Creek Monument Signs and Perimeter Fence Pictures

September 27, 2017 Hurricane Irma Damage Assessment

Fiddler's Creek Community Street Signs Irma Storm Damage Assessment

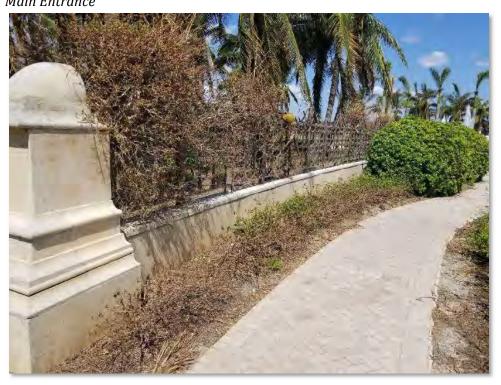
West Knee Wall and Railing

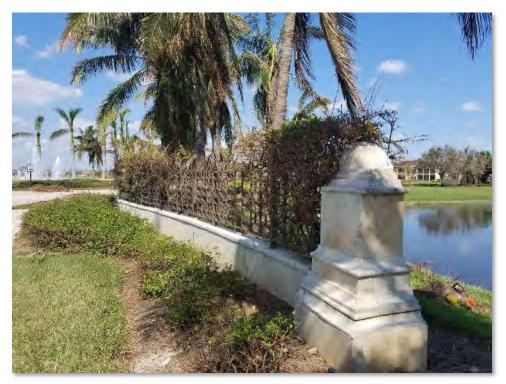
East Knee Wall and Railing

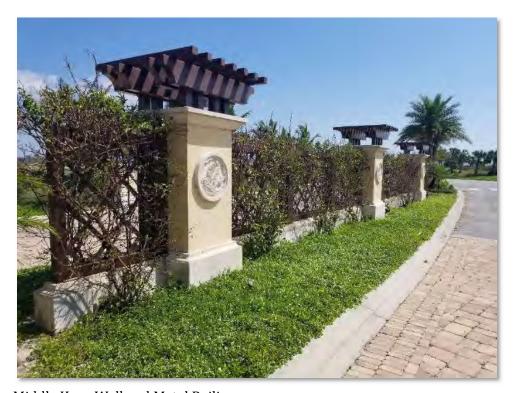
Middle Knee Wall and Metal Railing

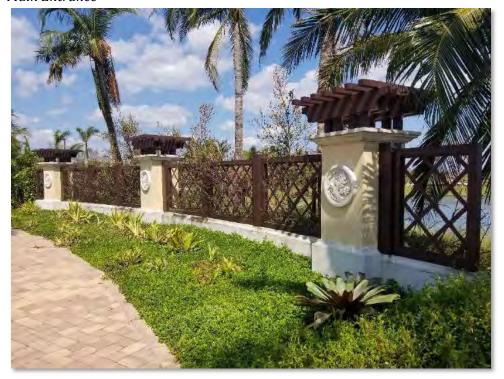
East Knee Wall and Metal Railing

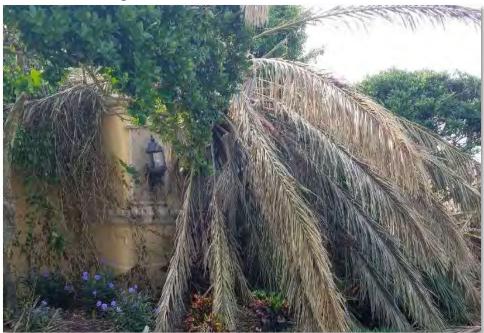
Misaligned Lighting Fixture Head

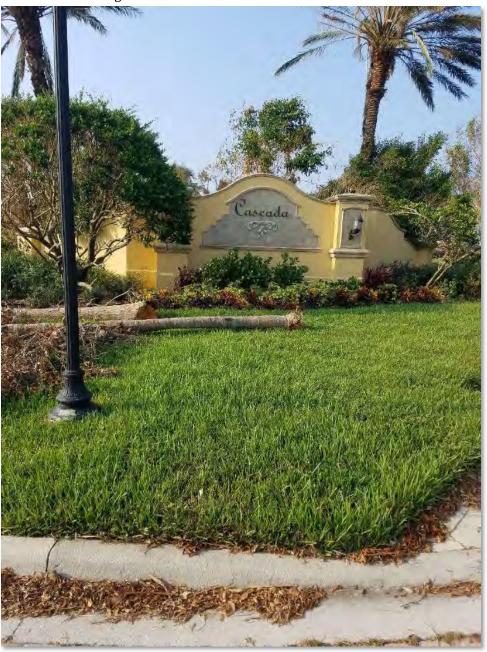
Cascada VillageSouth Monument Sign
